PENNSYLVANIA HISTORIC RESOURCE SURVEY FORM PHOTO/SITE PLAN SHEET

Address: 855 Penllyn Blue Bell Pike

SITE PLAN

Project Name: Whitpain Township Historic Resource Survey

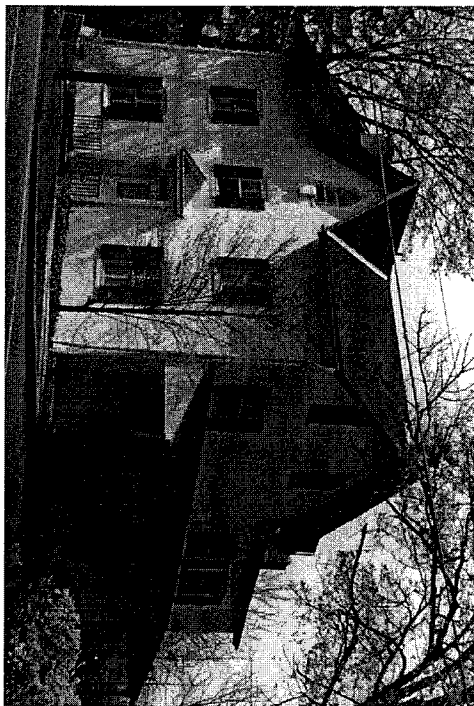
Classification: While this house is in good condition, the minor alterations cause it to be a Class II resource.

This house is a good example of Victorian Gothic architecture. It consists of a 20 x 30 foot core with a frame addition and a porch. The core is a two and a half story, three bay, end gable (asphalt shingles) structure with a centered gable over the door. The windows are two over two double hung with shutters. A pointed arch window in the center gable is a nice Victorian Gothic touch. Windows under the end gables are also angled to match the slope of the roof. A neoclassical door frame consisting of a nicely detailed Greek Revival pediment supported by two fluted pilasters frames the door. The core is clad in stucco, and it sports two interior end chimneys. The frame addition is a two-story element on a perpendicular axis. It has similar windows to those on the core. A simple end porch runs the length of one side of the core and the frame addition, resting on four simple, unfluted columns.
