PENNSYLVANIA HISTORIC RESOURCE SURVEY FORM PHOTO/SITE PLAN SHEET

Municipality: Whitpain Township

Address: 1201 Narcissa Road

Surveyor Name/Title: Robert Wise Date: 6/16/2000
Project Name: Whitpain Township Historic Resource Survey
Organization: Robert Wise Consulting/Whitpain Township Telephone: (610) 722-5818
Street and No.: Station Square 1, Suite 104, 37 North Valley Road
City, State: Paoli, Pa Zip Code: 19301
Additional Survey Documentation: _____ n/a
Associated Survey Codes: _____ n/a

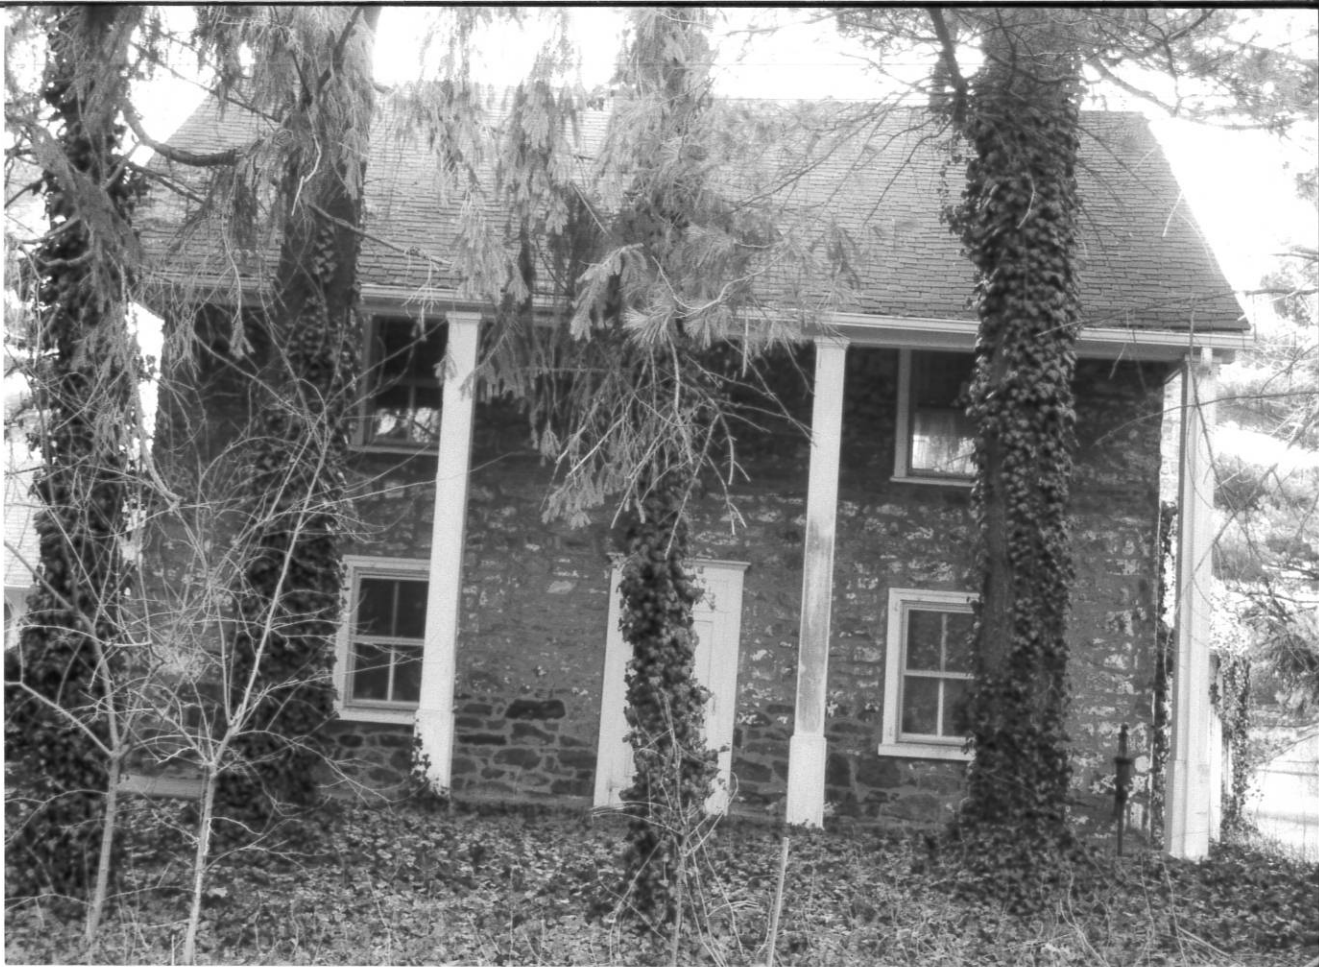
1 House – façade

This house is a vernacular farmhouse. Built c. 1800, this house is a two story, three bay house built of stone and formerly clad in stucco. The core is a 15 x 28 building with some additions that make it 28 x 45. It has end gables and an interior end chimney on the left side of the façade. The roof is covered with asphalt shingles and extends on the main façade ove. A two-story, full-length porch on the façade under an extension of the roofline rests upon four square columns and shades a six-paneled door. A small but distinct crown molding over the door is a fine period detail. A two story addition on the rear of this house is frame and has two one story wings of its own.
